ST DAVID & CYFELACH CHURCH, LLANGYFELACH - ARCHAEOLOGICAL WATCHING BRIEF

Prepared by DAT Archaeological Services
For: Emyr Davies A'I Fab Cyf

**REPORT NO. 2020-56
GGAT ERN E006596**

November 2020

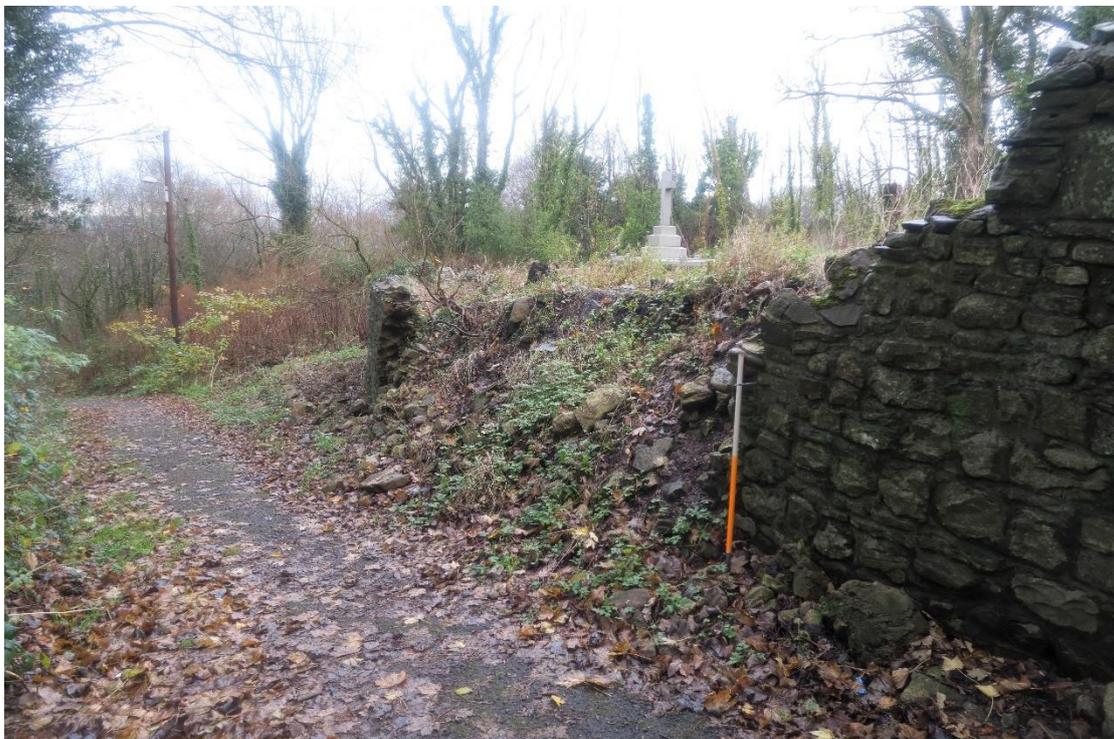
Photo 1: Initial area of wall collapse (Excavation Area 1) along Goat Lane, looking north. 1m scale.

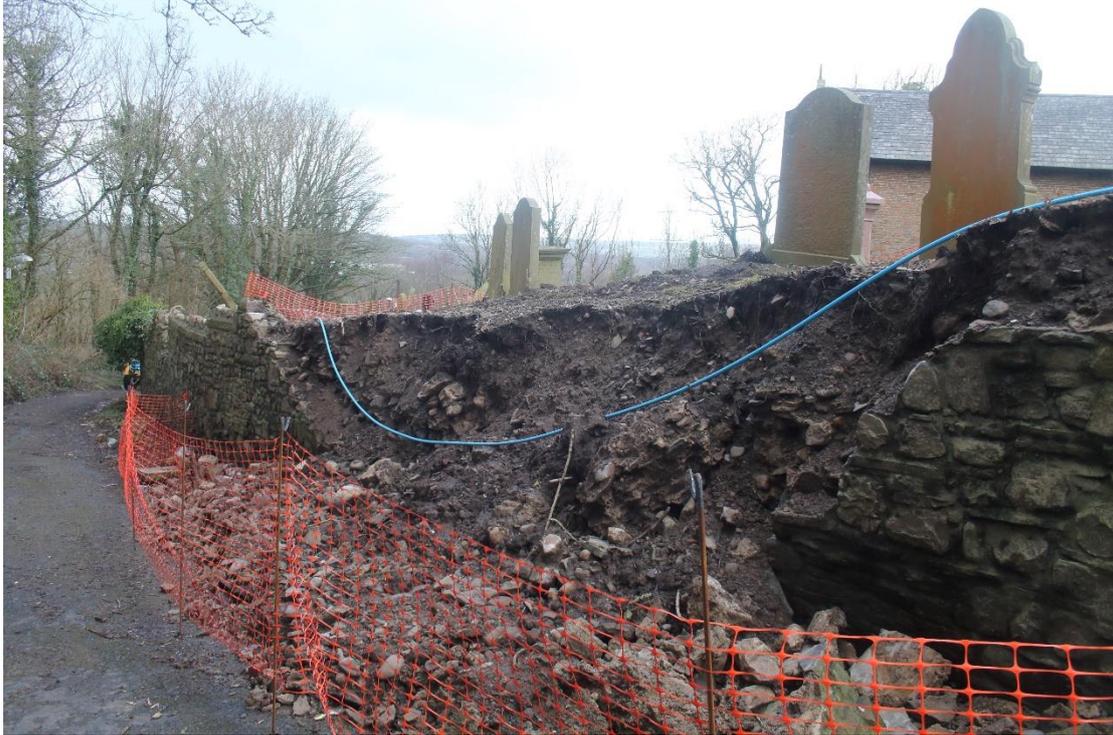
Photo 2: Second area of wall collapse (Excavation Area 2) along Goat Lane, looking northwest.

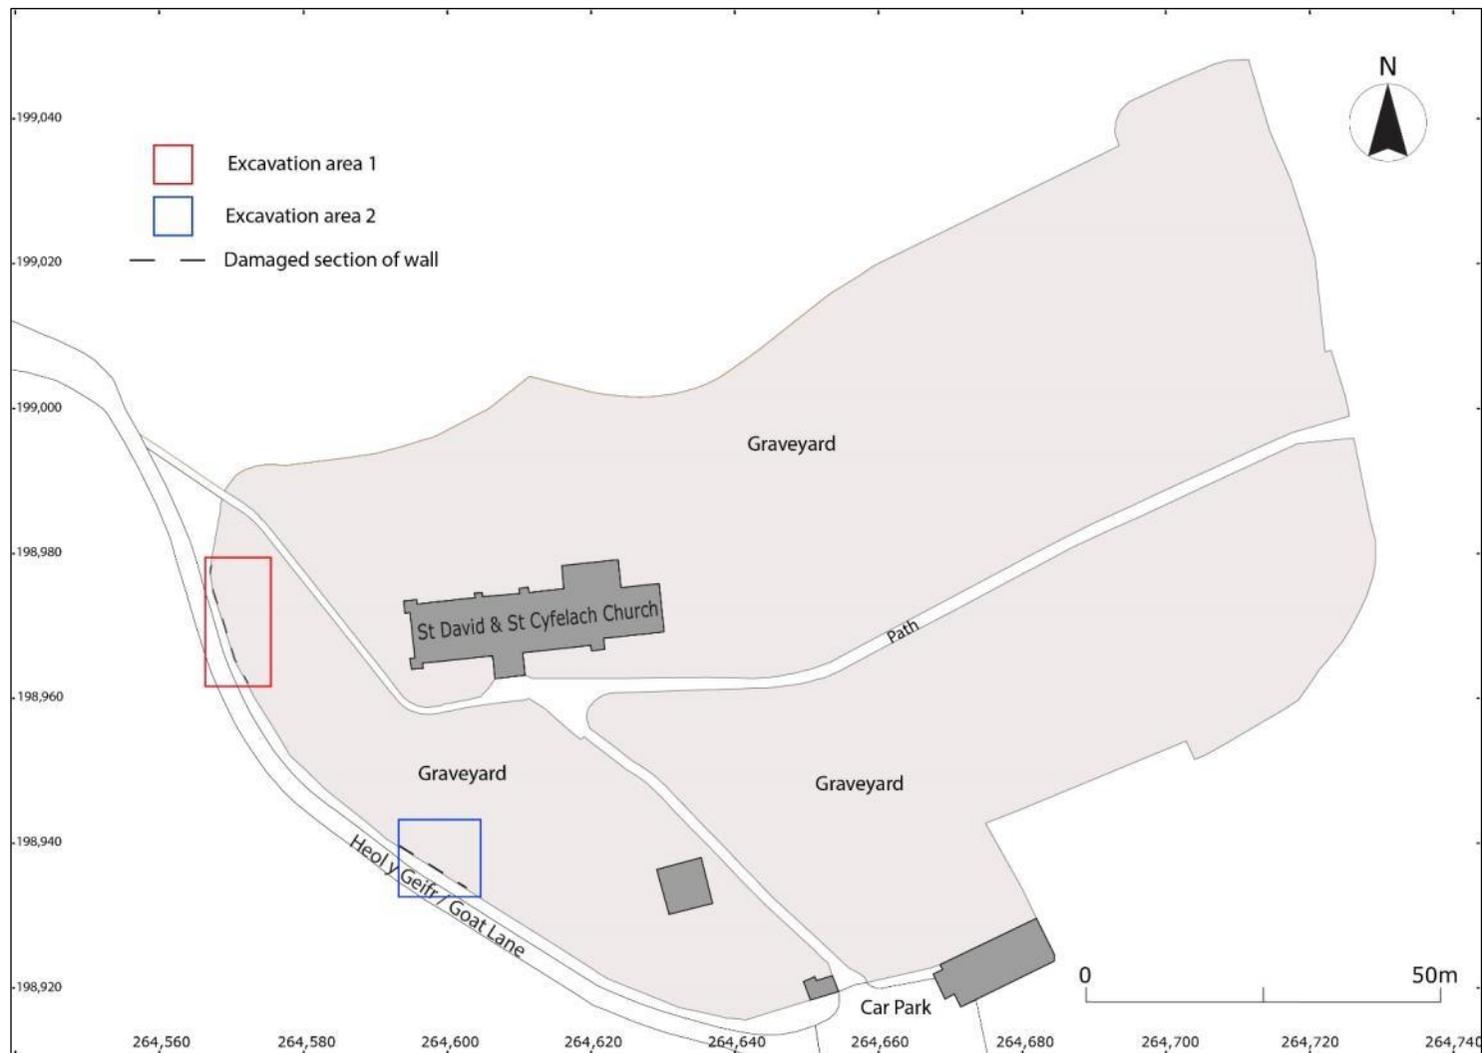
Figure 3: Overall plan of Llangyfelach Church showing archaeological watching brief areas.

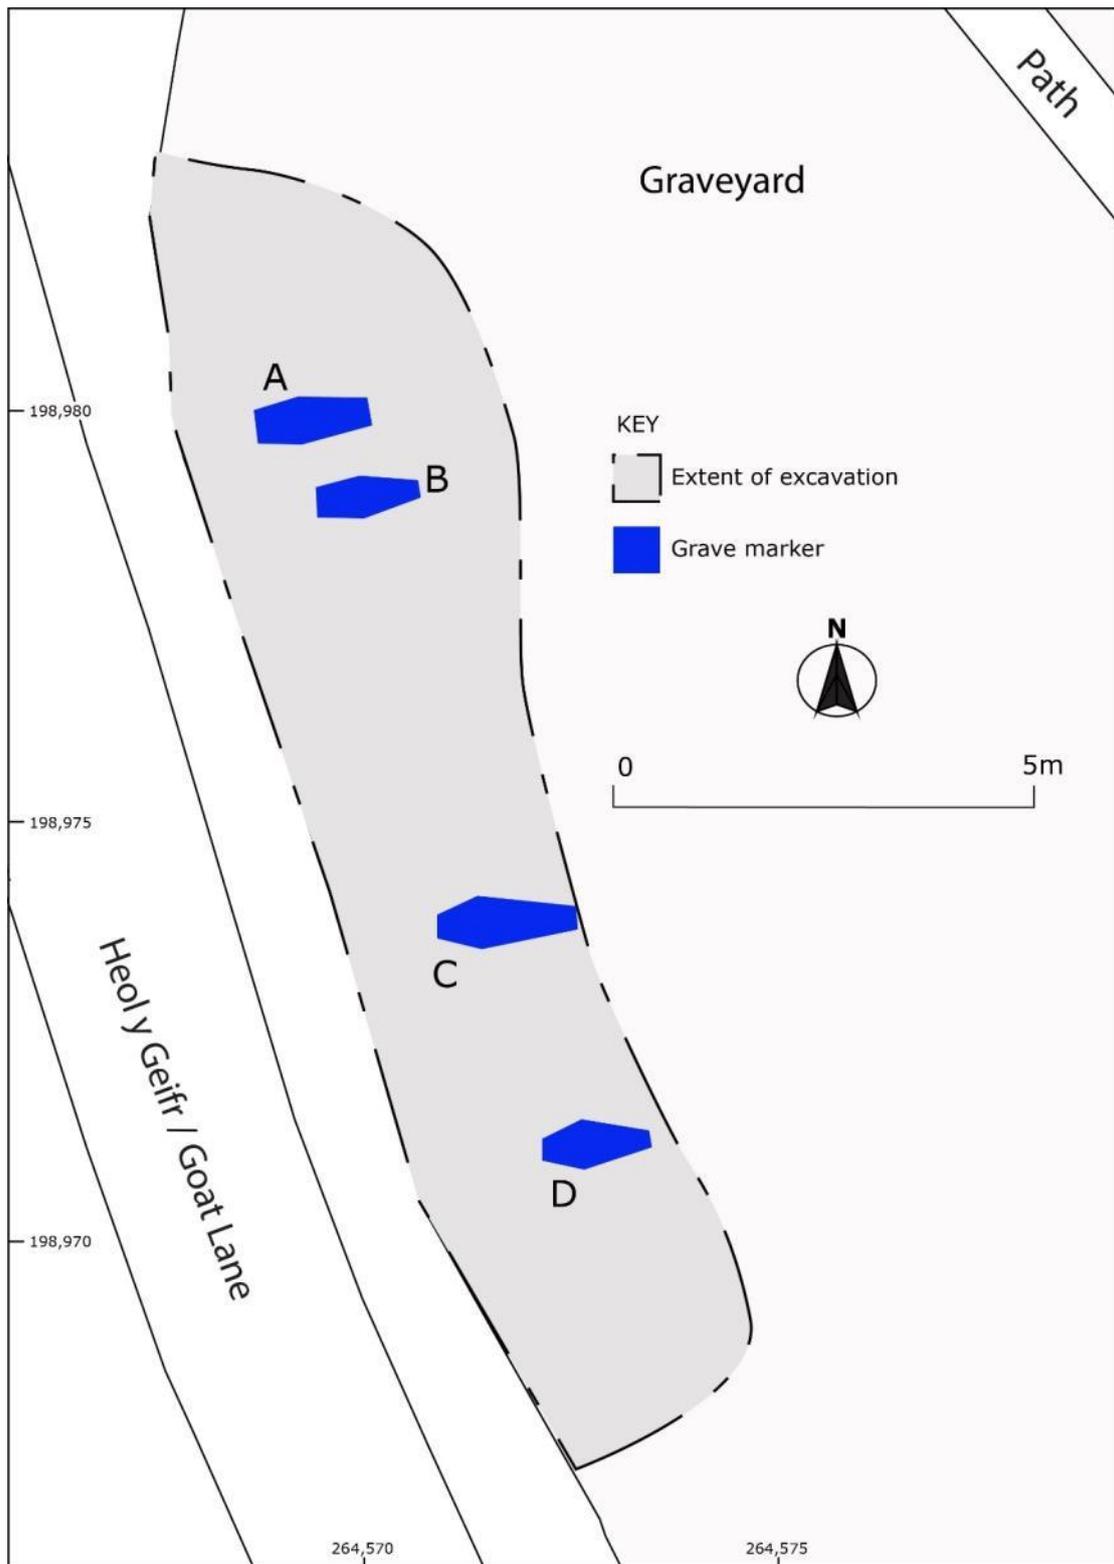
Figure 4: Grave marker survey of Excavation Area 1.

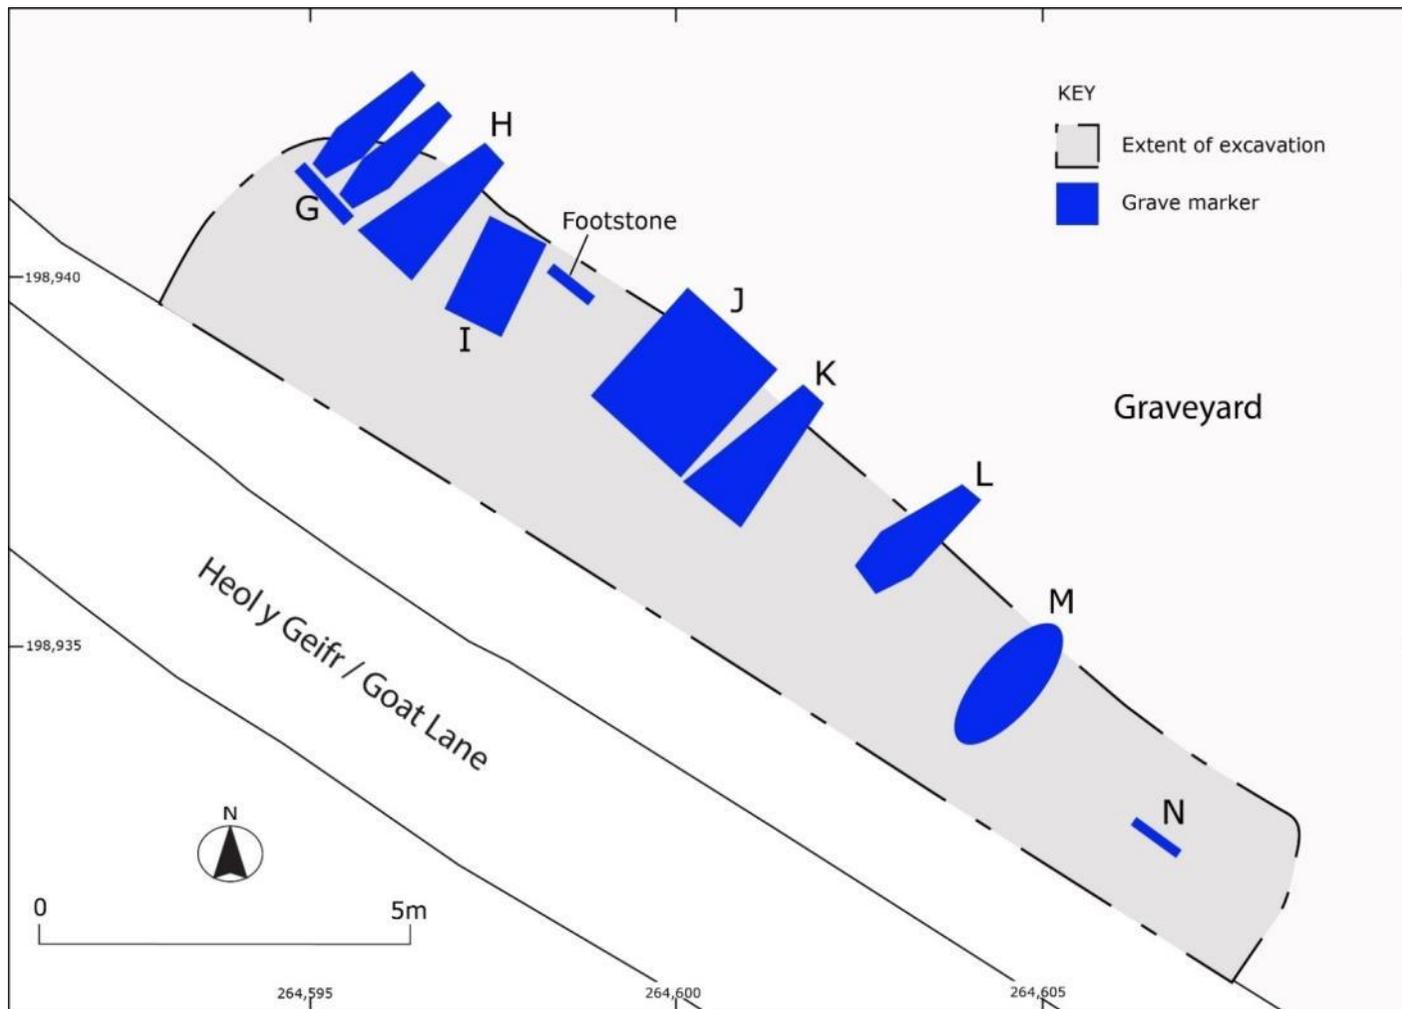
Figure 5: Grave marker survey of Excavation Area 2.

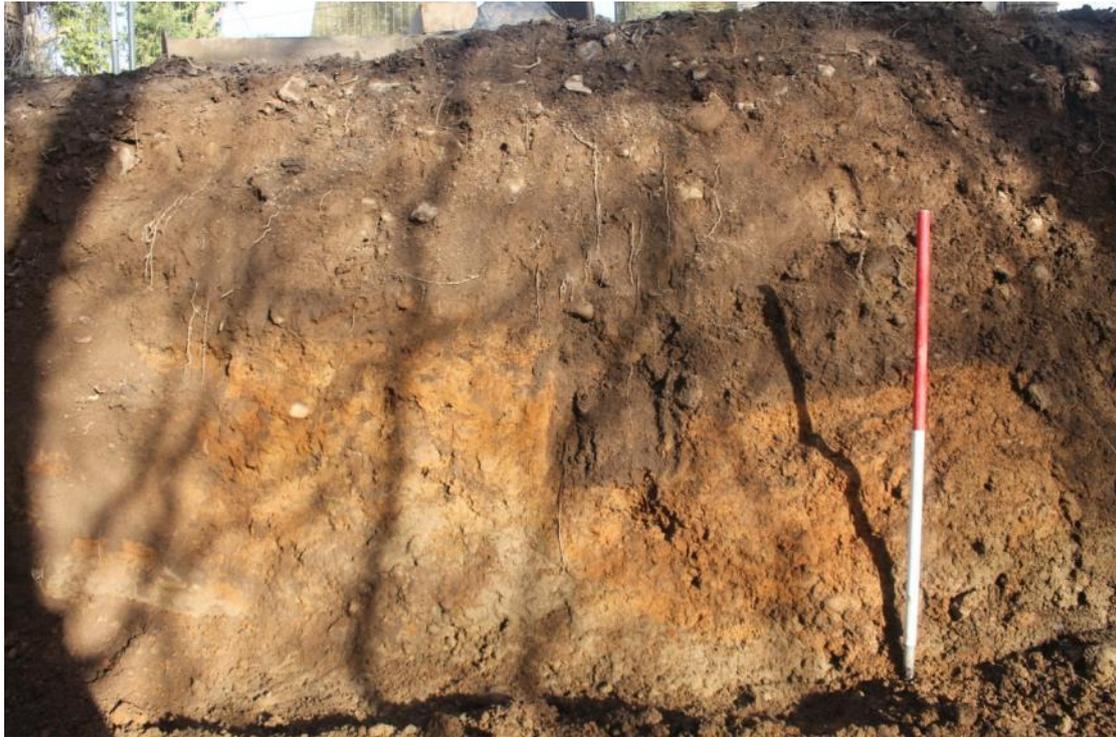
- 4.2.2 In each Excavation Area the earliest deposit observed was the natural horizon, consisting of a compact grey silty clay. It was very stony and hard and had evidence of graves cutting into its upper levels. The natural horizon undulated throughout the excavation area but was seen at an average depth of 1.10m below current ground level.

- 4.2.3 Overlying the natural horizon was a 0.40m thick layer of compact orange silty clay, referred to as the natural subsoil. This deposit seemed largely undisturbed, aside from the grave cuts that truncated it from the deposit above. Grave cuts were clearly discernible within this deposit due to the contrasting fills, and these are described individually below. This subsoil deposit was overlain by a friable mid-brown, silty clay, approximately 0.55m deep and referred to as the cemetery layer. This is a generally disturbed layer, and would appear to be the active ground level from which the burials are cut.

Photo 12: Representative section of the soil profile in Excavation Area 1. Showing the light grey natural ground, overlaid by an orange subsoil, with darker siltier cemetery soil and topsoil above. Note also the grave cut visible towards the centre. View east, 1.0m scale.

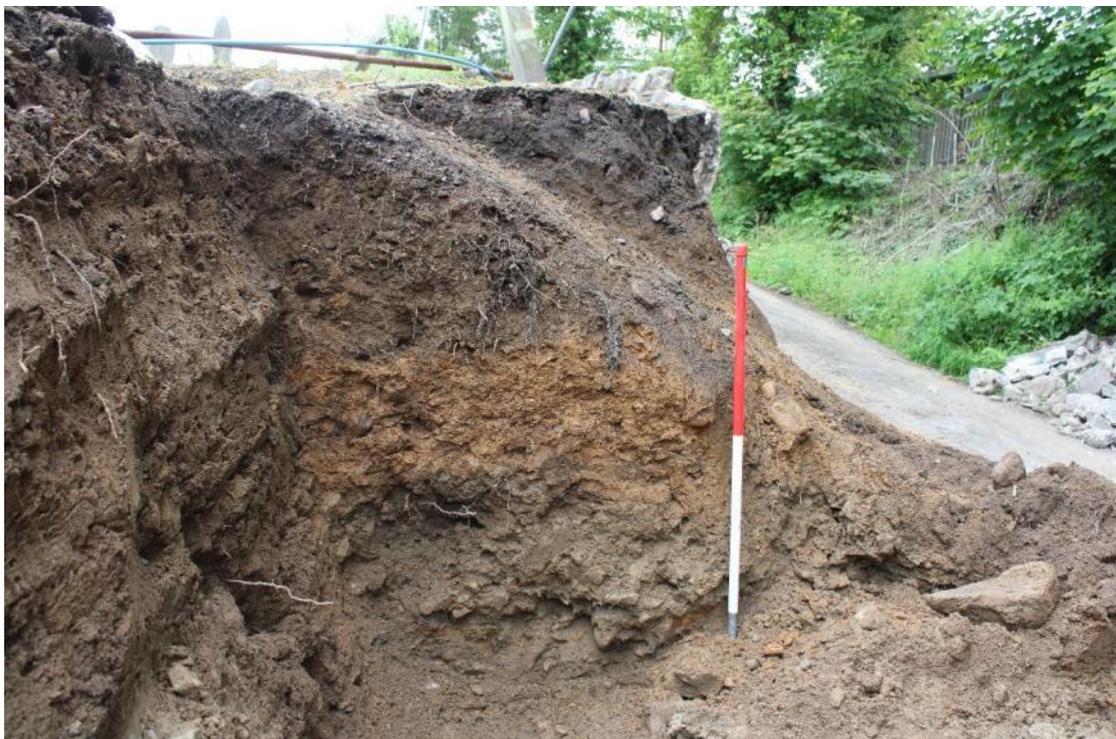
- 4.2.4 Both Excavation Areas were overlain by a 0.15m thick layer of topsoil and turf, consisting of a very loose dark silt. Photos 12 and 13 illustrate the soil profiles seen in each Excavation Area.

Photo 13: Representative section of soil profile in Excavation Area 2. The natural ground is visible at the base, overlaid by orange subsoil midway up, with the darker cemetery soil and topsoil above. View southeast, 1.0m scale.

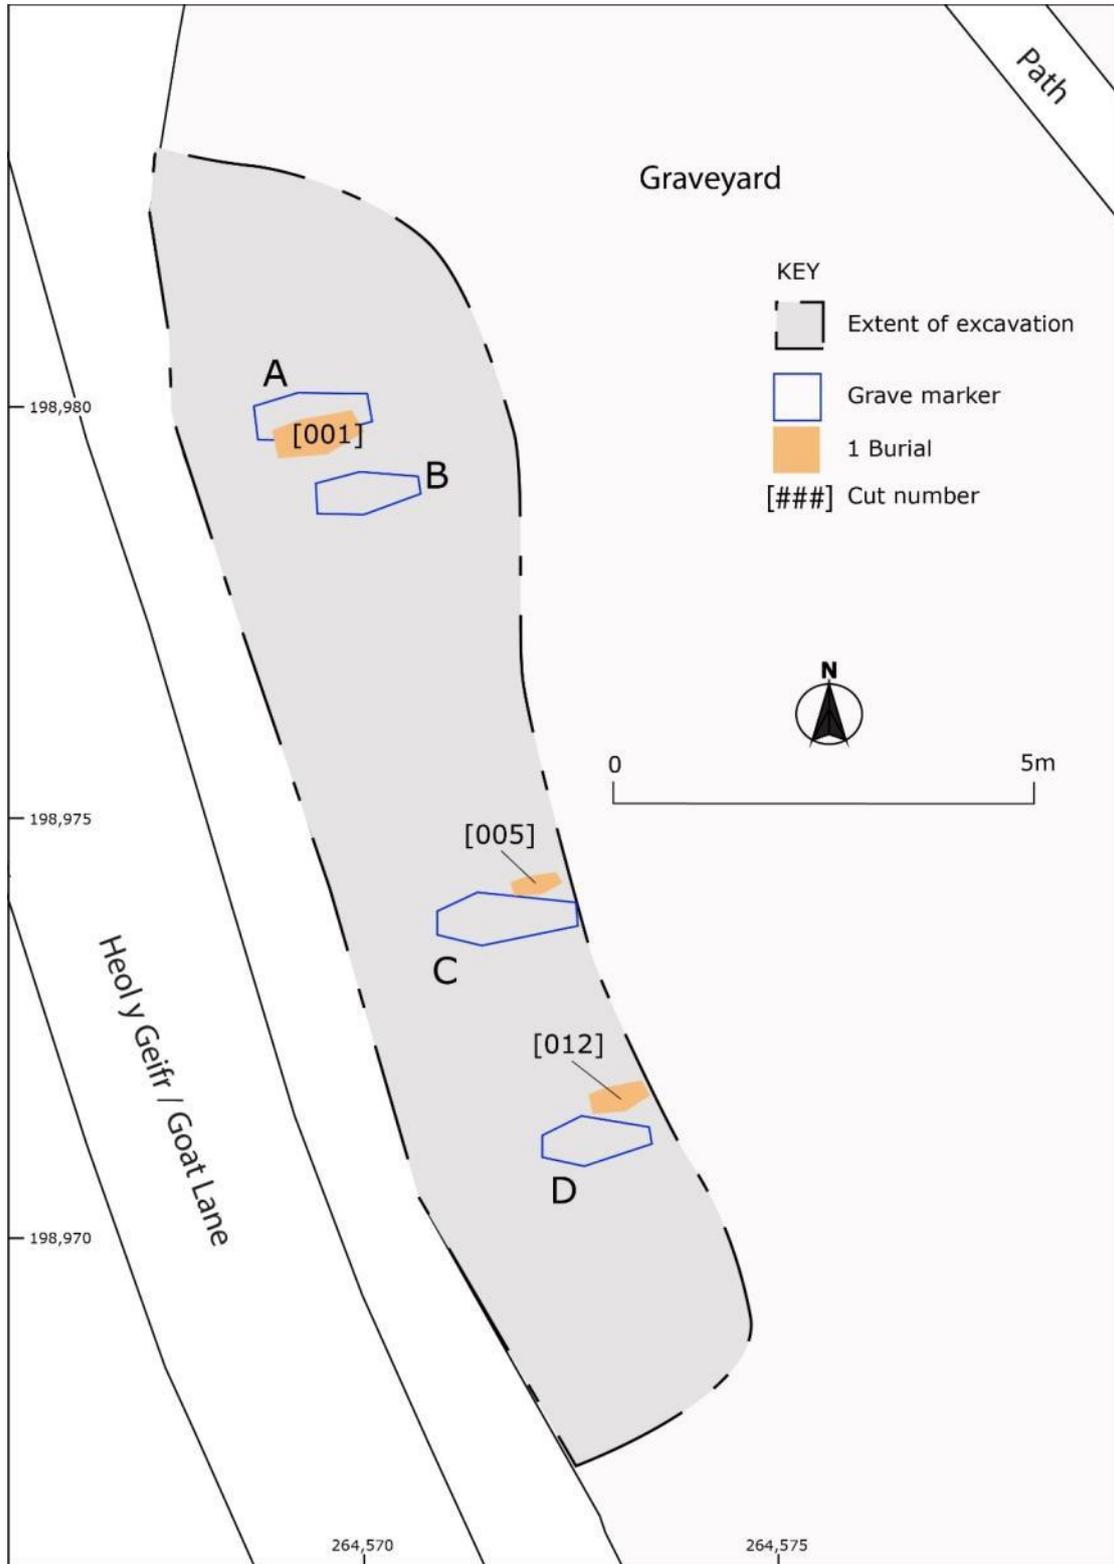
- 4.3.1 A total of seventeen graves, containing twenty-six burials, were excavated during the works. Some were individual graves, while others contained vertically stacked burials. Figures 6 and 7 illustrate the distribution of the excavated burials. A Harris matrix has also been created to demonstrate the sequence of depositions observed during the groundworks and can be seen in Figure 8. The coffins, burial structures and skeletal remains are discussed in more detail in sections 4.4 and 4.5.

Figure 6: Distribution of burials excavated in Area 1.

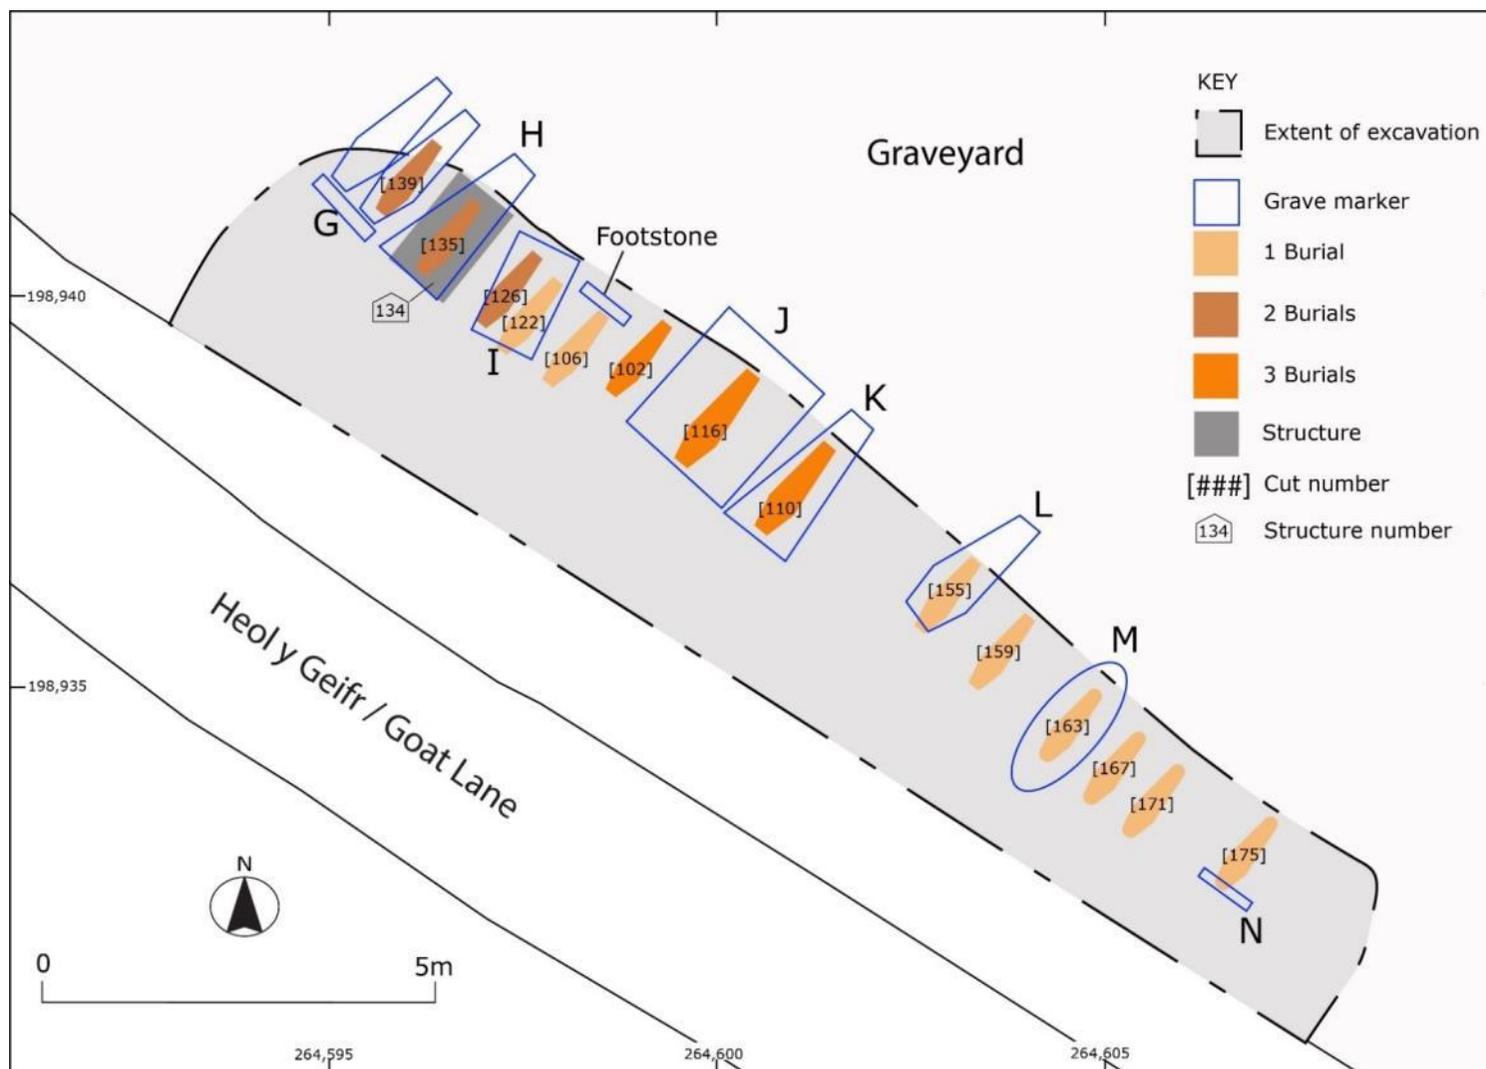
- 4.3.7 Each burial encountered was approximately oriented west-east with the head to the west. However, the graves in Area 2 were on a northeast-southwest alignment; this appears to follow the curvature of the churchyard wall in this area and was possibly done to save space. Almost all of the graves were truncated by the limits of the excavation, resulting in the exposure of only the upper half of the inhumations within.

Figure 7: Distribution of burials excavated in Area 2.

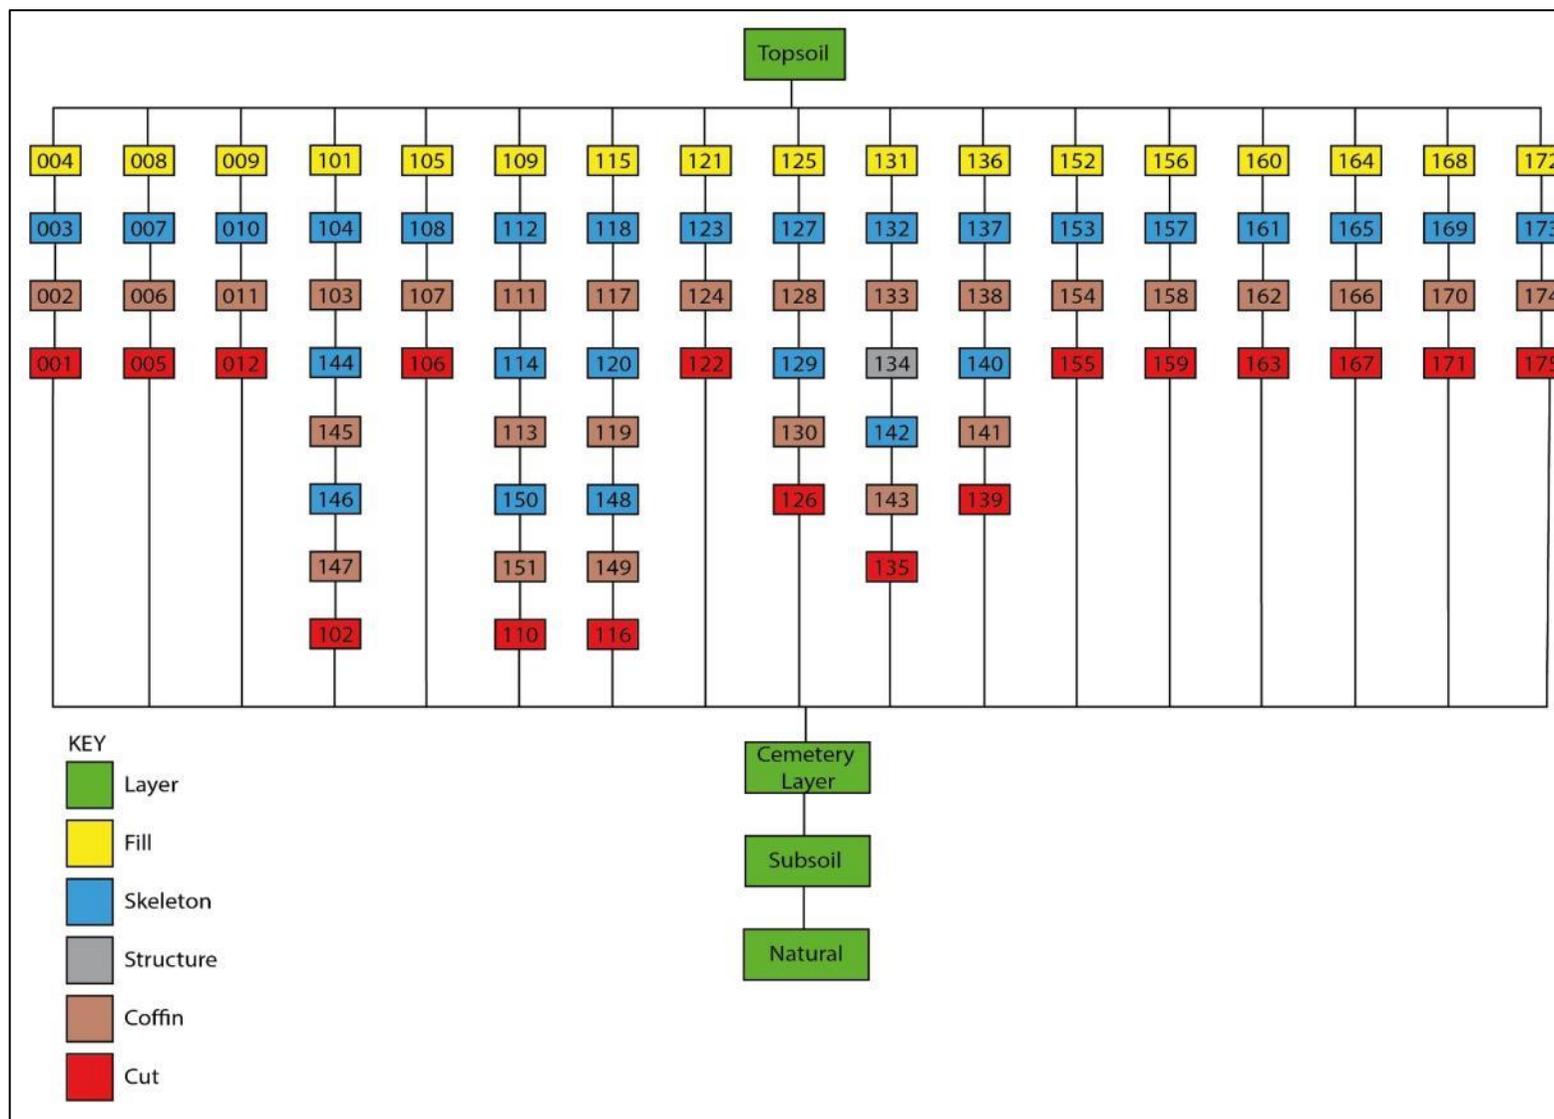
Figure 8: Harris matrix showing sequence of deposition.

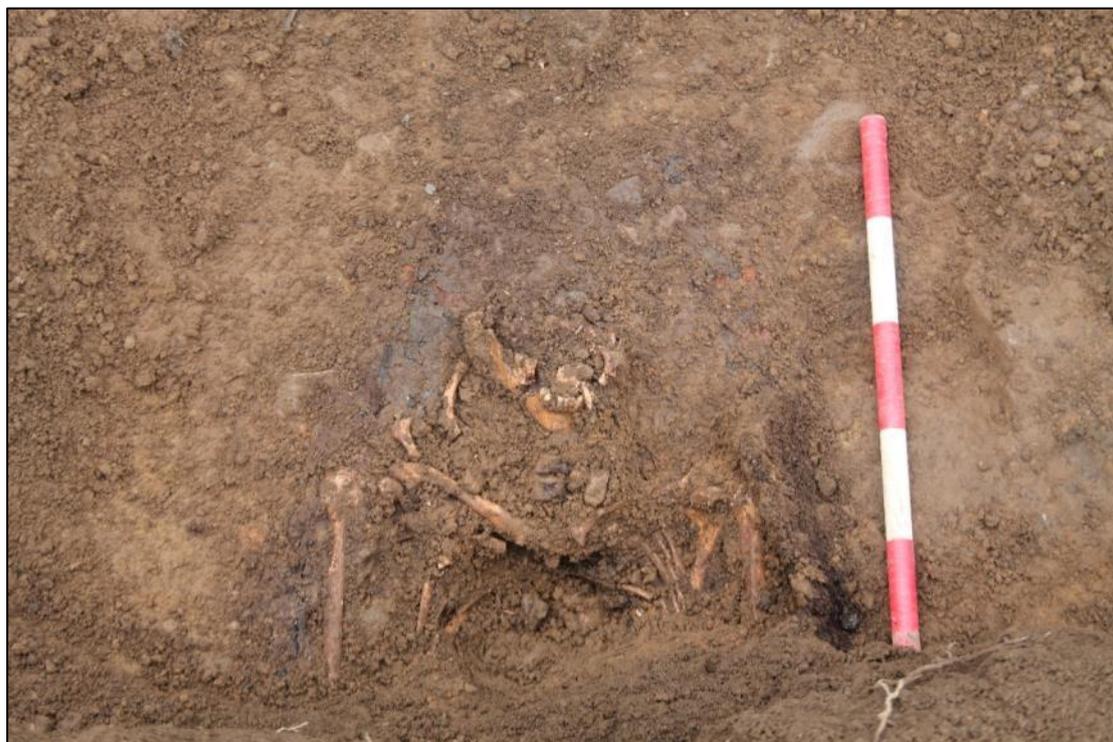
- 4.4.1 Evidence for coffins was observed with every identified burial, but in general, coffin preservation was very poor across both Excavation Areas. The depth at which coffins were encountered ranged from 1.25m to 1.75m below current ground level. In most instances, remnants of the coffin only survived as black staining around the skeletal remains (Photo 14). In a few cases the coffin wood had survived in a petrified state but showed evidence of collapse prior to excavation. Photos 15 and 16 show the state of coffin (117); one of the "better" preserved coffins that was observed.

Photo 14: Coffin (011) survives as a black staining around the skeletal remains of (010). View west. 0.5m scale.

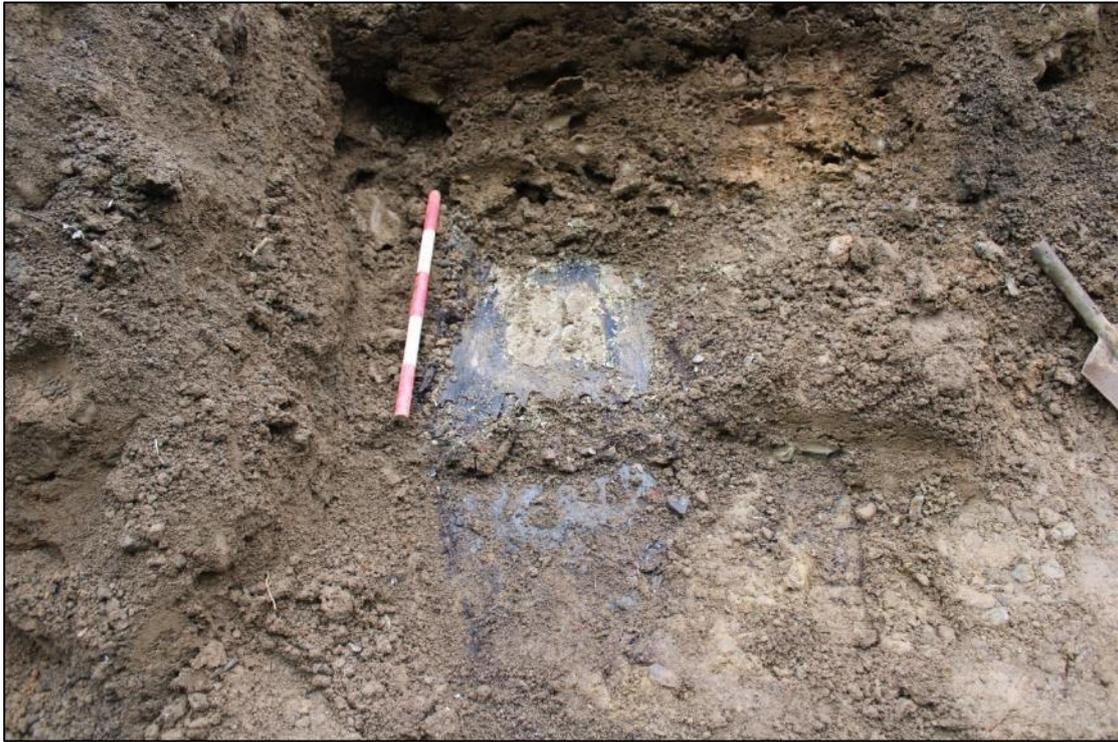
Photo 15: Exposing coffin (117), associated with grave [116], one of the better-preserved coffins found on the site. View east. Scale 0.5m.

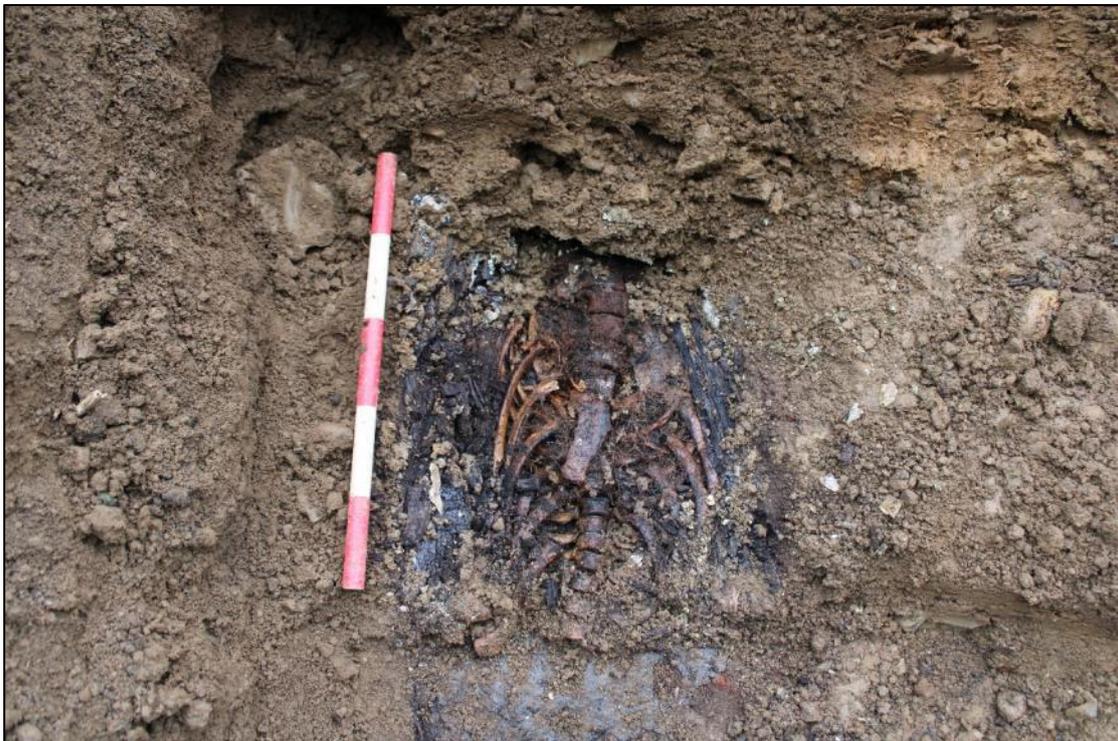
Photo 16: Coffin (117) after removal of the lid. View west. Scale 0.5m.

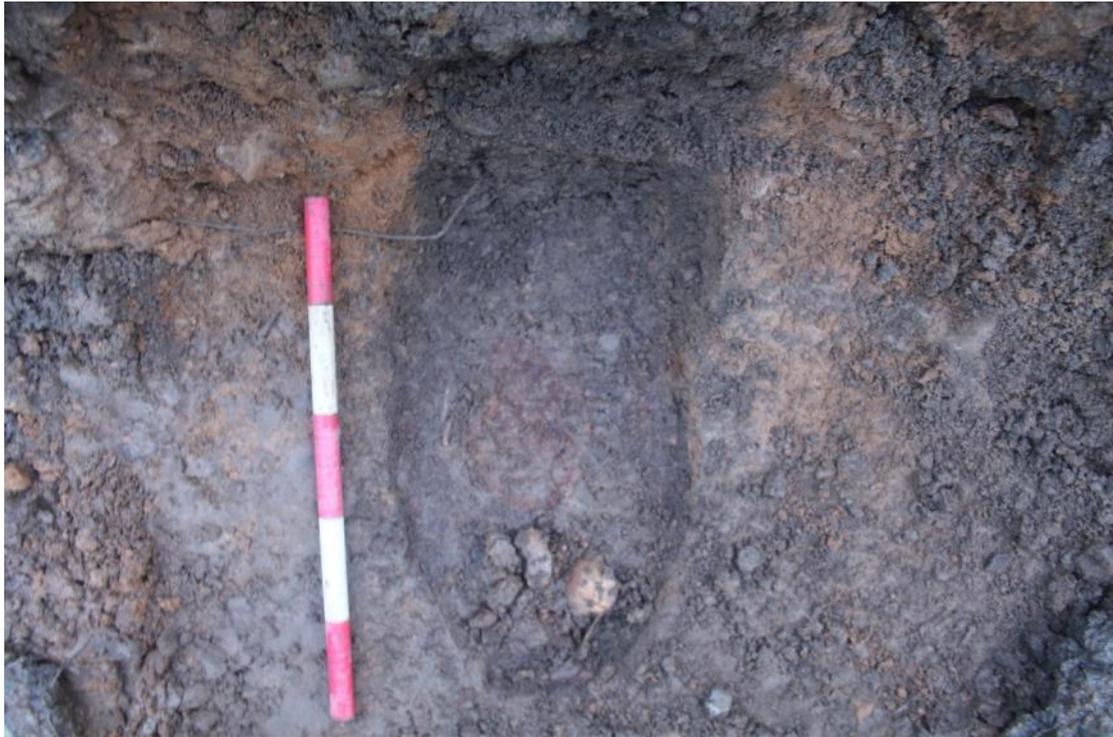
- 4.4.3 Only one surviving coffin plate was retrieved during the ground works. This was associated with coffin (133) (discussed below), with coffin handles also found *in situ*. Both had been preserved by the presence of a grave structure. In most instances evidence for a coffin plate survived only as a rust staining, as illustrated in Photo 17.

Photo 17: Evidence for a coffin plate survives as staining present on coffin (006), with grave [005]. View east. 0.5m scale.

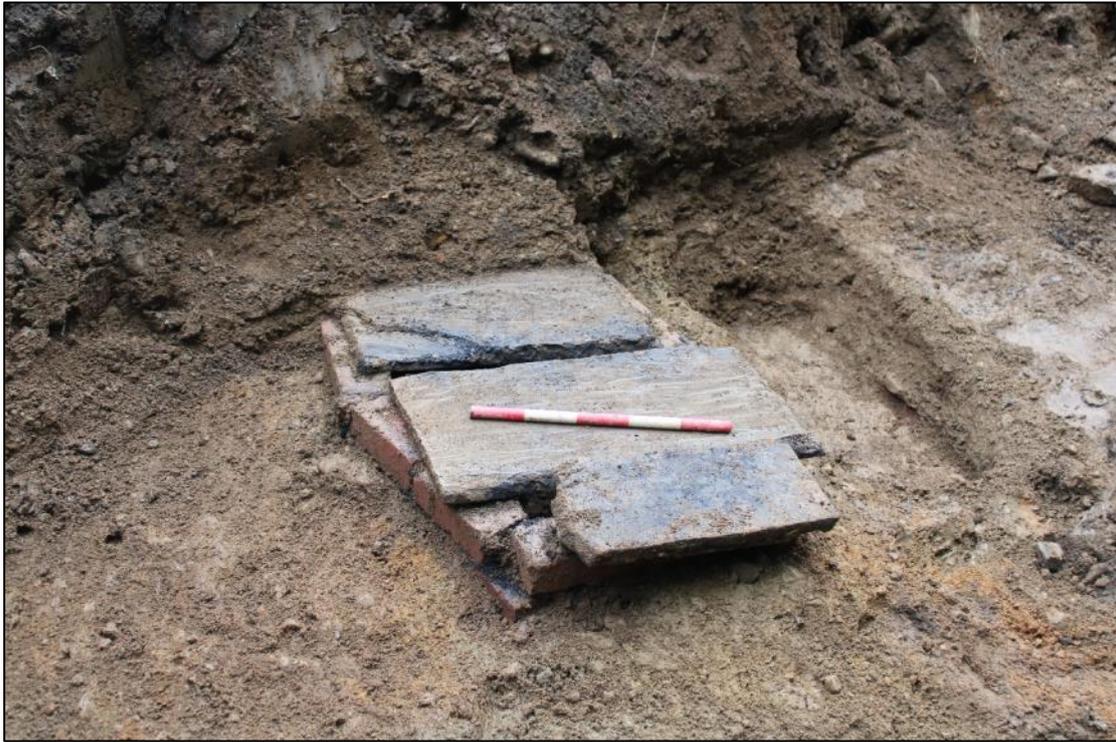
4.4.4 Only one built grave structure was encountered. Within grave cut [135] a brick-built structure {134} was encountered at a depth of 0.90m and was associated with grave marker H. This structure was shouldered and tapered in form, built of machine-made frogged brick bonded in a dark mortar with ash inclusions, and was capped with large slate slabs (Photos 18 - 20). Contained within the structure were coffin (133) and skeleton (132). The coffin and skeletal remains within were in a poor state of preservation but the coffin handles and a coffin plate survived, making this the only definitively identifiable burial. The plate was inscribed with the name Mary Williams, who was born in c.1839 and had died in 1892. This was consistent with information present on the grave marker (H). The grave marker indicates a further three burials present within the grave, those of Mary's husband and two daughters, all of whom died at an earlier date. Only one further individual was encountered (skeletal remains 142), likely those of her husband William Williams who died in 1873. The remaining two burials are likely to have been fully decomposed.

Photo 18: Grave structure {134}. View southeast. 0.50m scale.

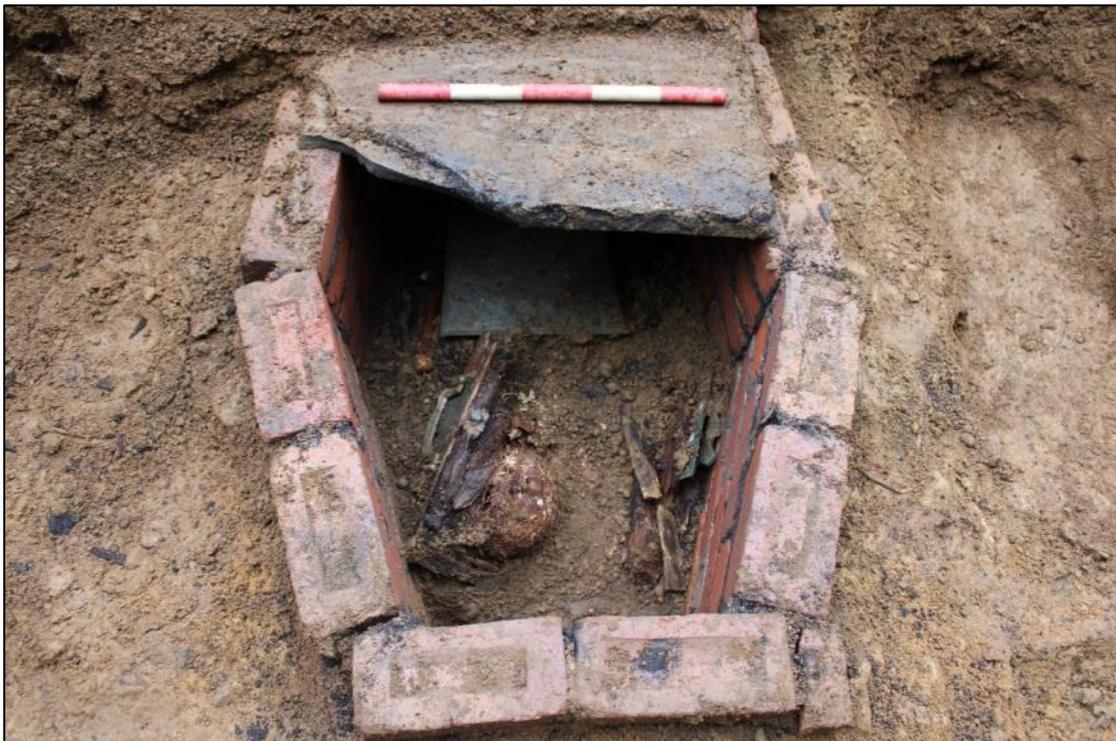
Photo 19: Grave structure {134} with capping stones removed exposing skeleton (132) within. View northeast. 0.50m scale.

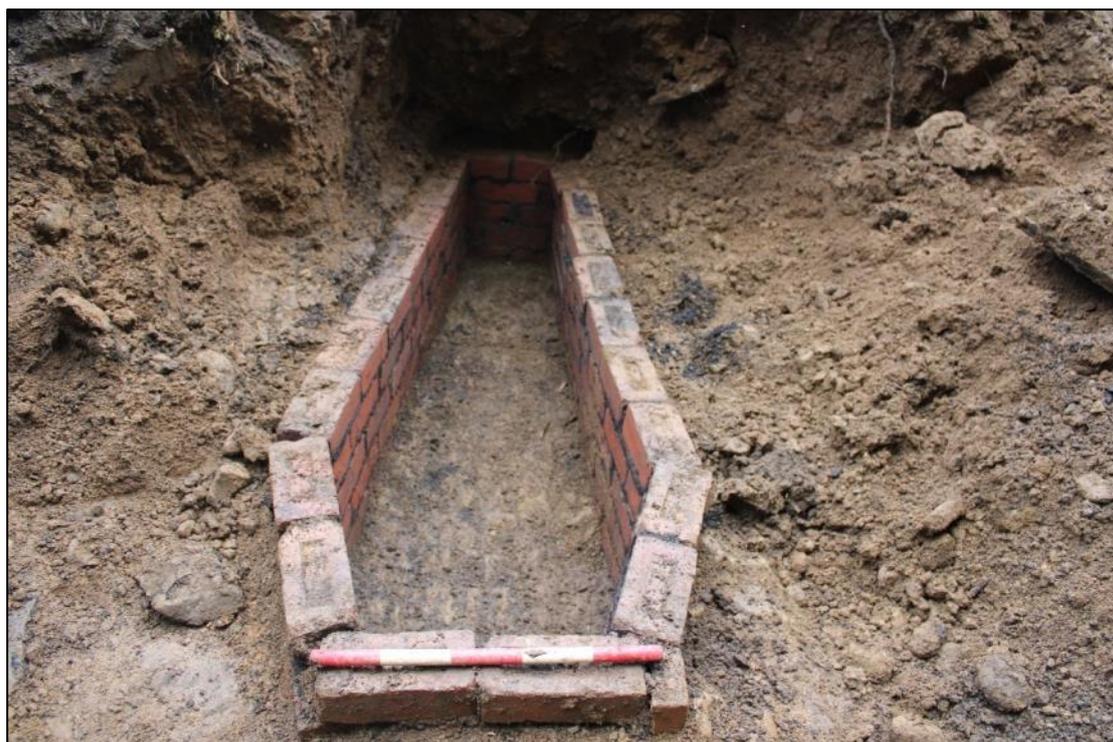
Photo 20: Structure {134} following removal of capping stones and interred remains. View northeast. 0.50m scale.

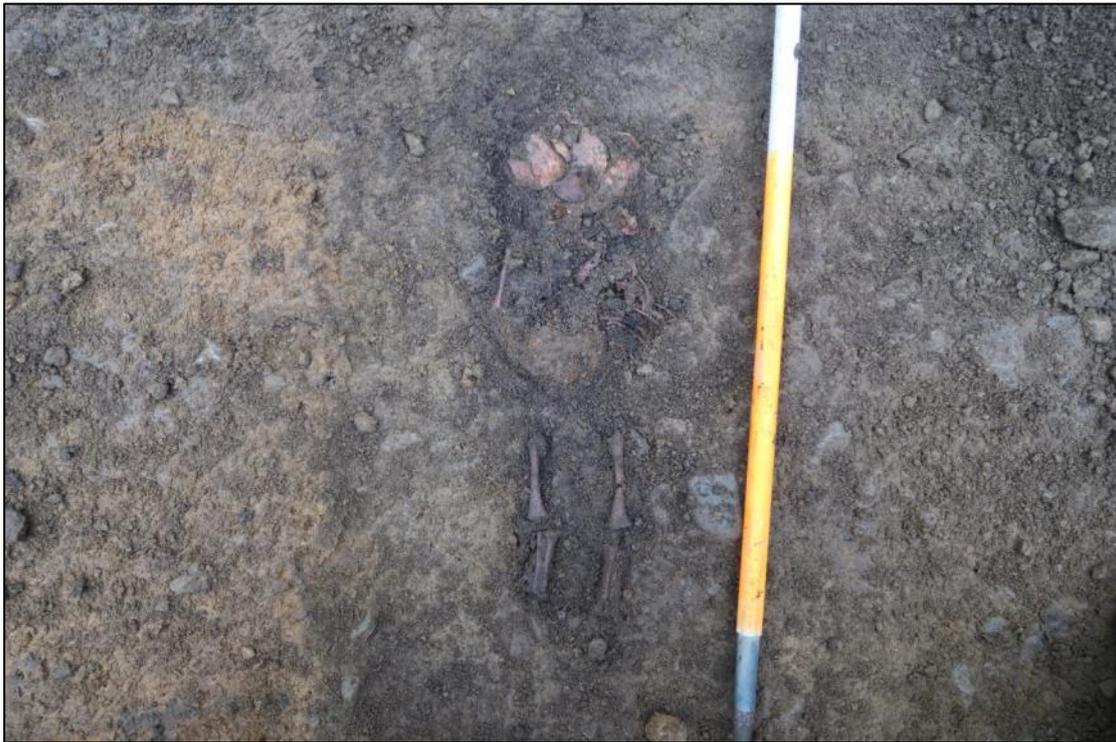
- 4.5.3 The human remains encountered were in a poor to moderate state of preservation. In most of the burials observed the smaller bones were not present, with only the longer bones and vertebrae surviving, although rib bones were recorded with skeletal remains (118) (Photo 16). Skulls were generally in fragmentary conditions, the better preserved examples being skeletal remains (132) (Photo 19), which had been preserved by the surrounding grave structure (although other than long bones bone preservation was otherwise poor), and skeletal remains (140) (Photo 22). Many of the remains appeared to be those of juveniles, but corresponding grave marker inscriptions would suggest at least some of these are likely to have been adult burials. Named infant burials appear not to have survived, although one infant burial, skeletal remains (003), was exposed within Excavation Area 1 (Photo 21).

Photo 21. Skeletal remains (003) of an infant, in unmarked grave [001]. View west. Scale in 0.5m intervals.

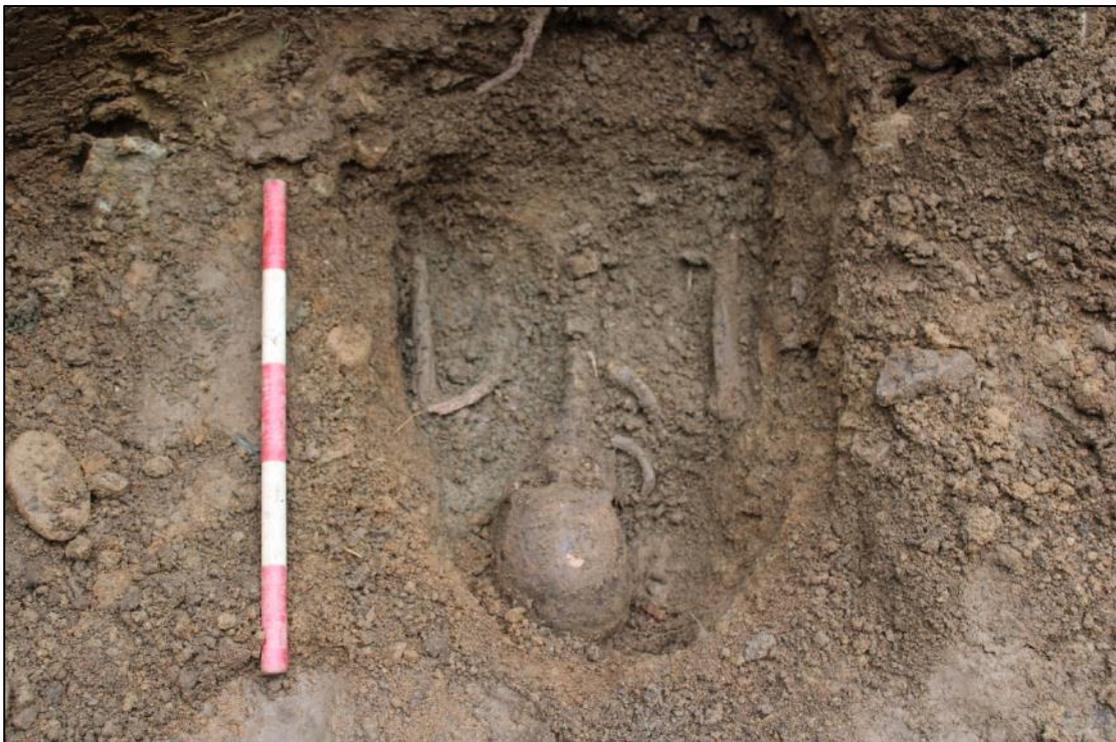
Photo 22: Skeleton (140), within grave [139], partially exposed within the excavation area. View east. 0.5m scale.
