ST DAVID & CYFELACH CHURCH, LLANGYFELACH - ARCHAEOLOGICAL WATCHING BRIEF

Prepared by DAT Archaeological Services
For: Emyr Davies A'I Fab Cyf

**REPORT NO. 2020-56
GGAT ERN E006596**

November 2020

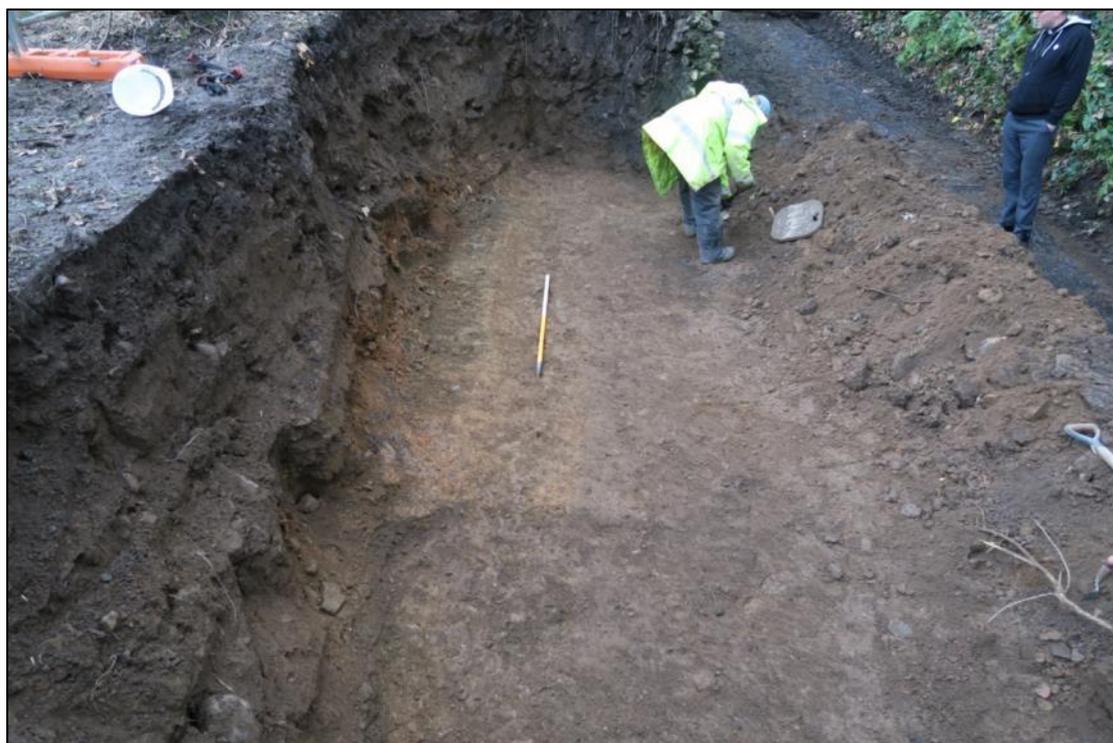
- 4.6.1 Along the western length of Excavation Area 1, and directly behind the wall was a much darker – almost black – very loose silt containing fragments of disarticulated bone, broken glass and modern pottery. When the area was hand-cleaned, a linear cut was seen aligned roughly north – south. This appears to run parallel with the existing wall, with the loose soil described above contained within the cut. This was presumably a cut associated with the existing graveyard wall (Photo 23).

Photo 23: A linear cut aligned north-south parallel with the existing wall likely represents an associated construction cut. View south, 1.0m scale.

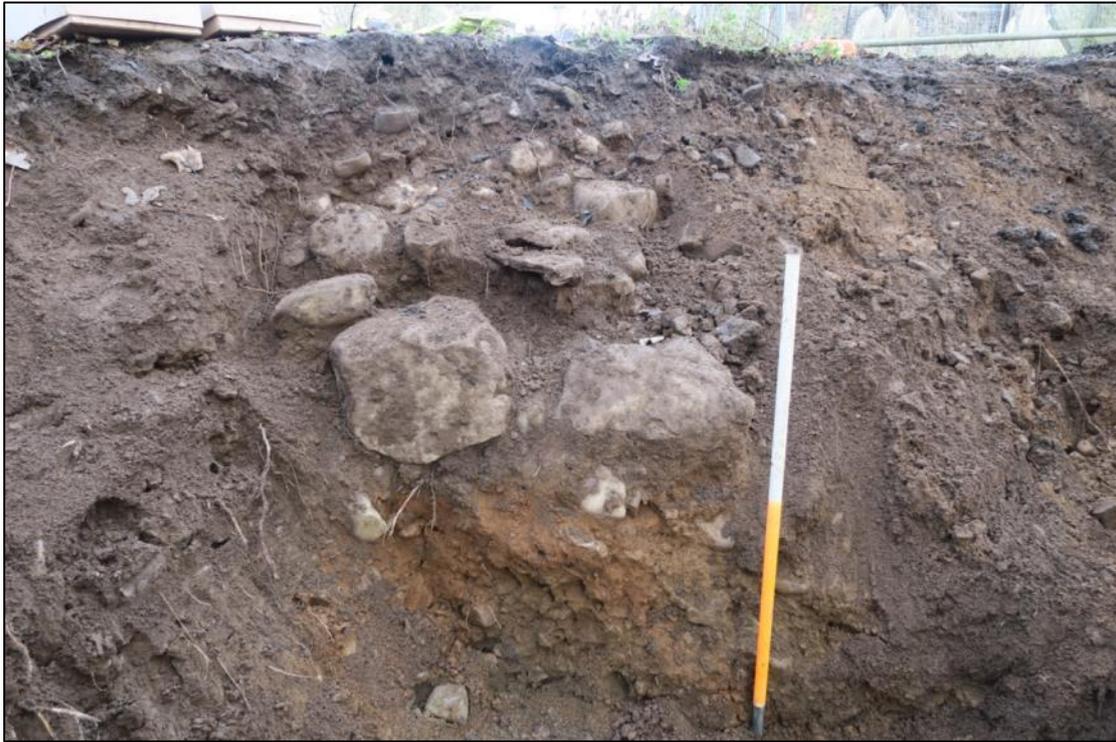
- 4.6.2 To create a safe working area it was necessary to batter the edges to create a receding slope. In doing so a number of medium-large stones were observed within the mid brown silty clay cemetery soil, beneath the topsoil, in the west-facing section of Excavation Area 1 (Photo 24 - 25). Although frequent stones had already been noted throughout this deposit, the siting of these examples appeared more organised. At the base were two large stones, potentially faced on their western edges, with a collection of medium-sized stones placed over them. As these were situated on the edge of the excavation area they were left *in-situ* and it was not possible to examine the feature any further to determine if it represented a built structure, such as a linear wall foundation, or part of a grave structure.

Photo 24: Collection of stones in the east facing section. View east, 1.0m scale.

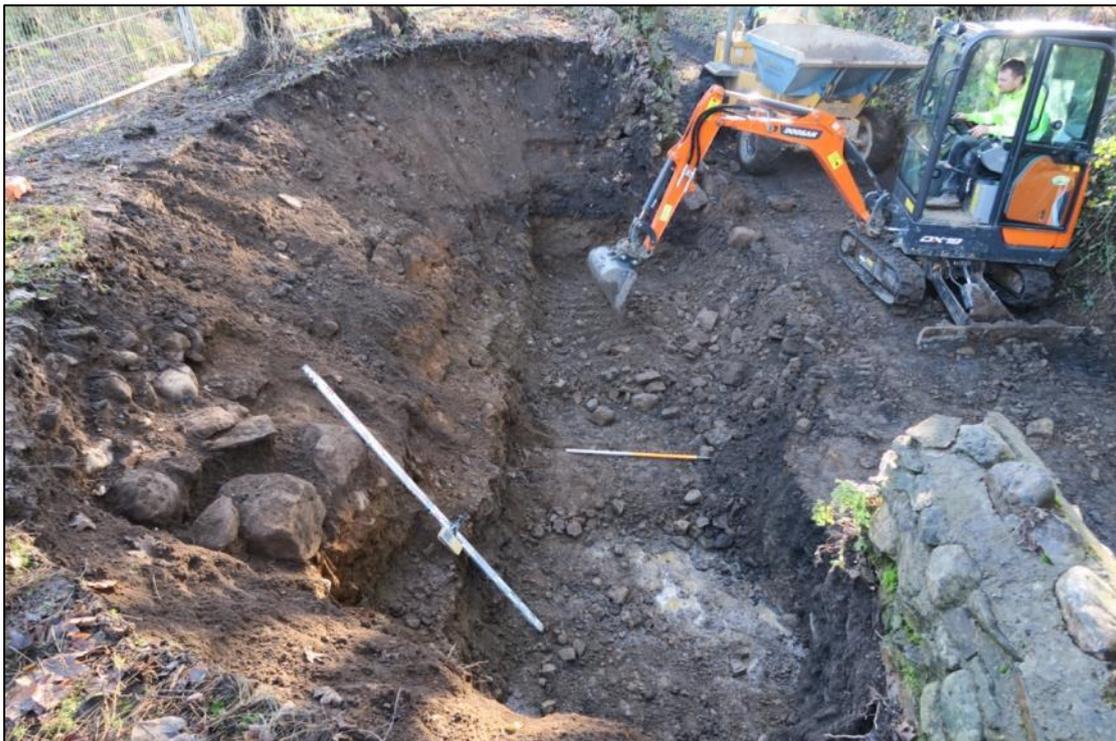
Photo 25: The excavated area at the end of the excavation of area I. View south.
Note the collection of stones in the west facing section.

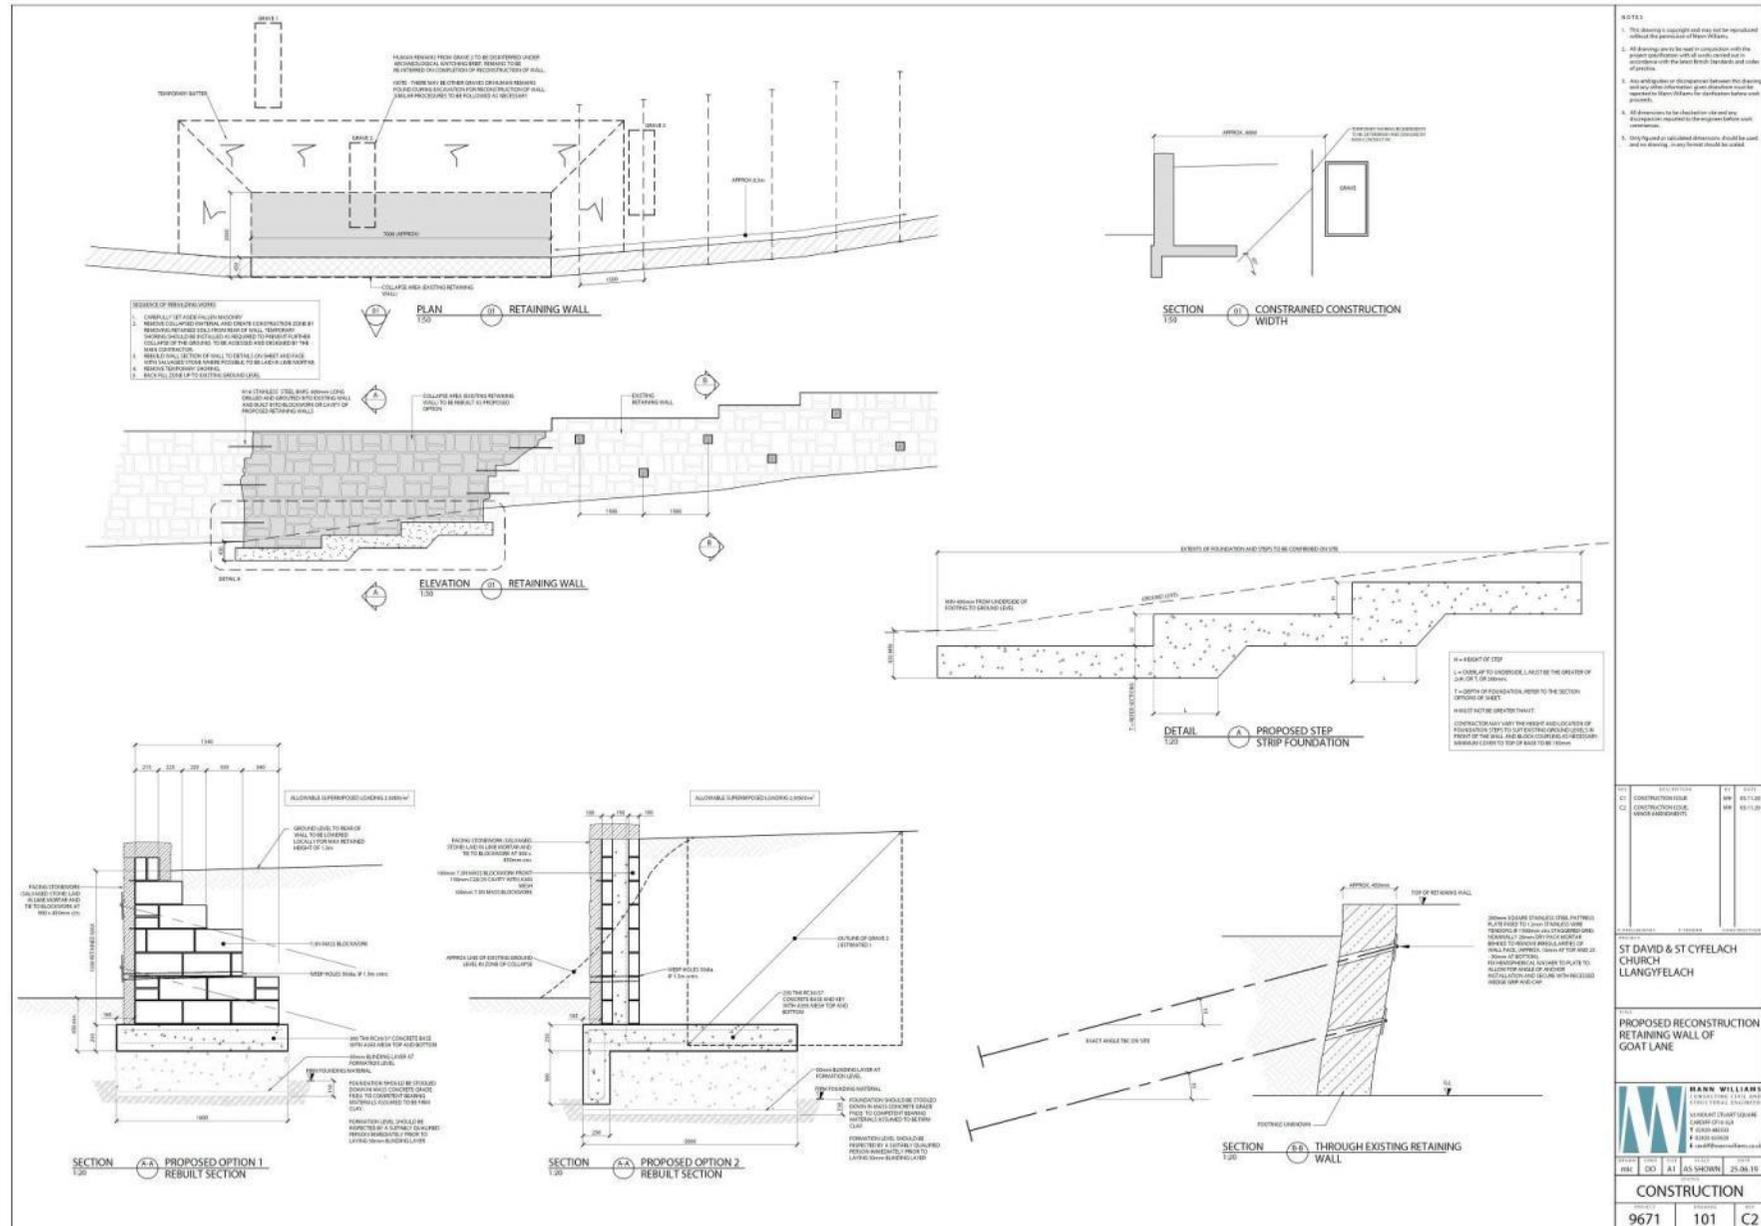
Figure 3: Details of proposed wall reconstruction. Not reproduced to scale.

4.2 The work to clear and rebuild sections of the wall on Heol y Geifr (Goat Lane) will require spoil and loose material to be removed and a safe working surface created prior to rebuilding (Figure 3). These groundworks have the potential to expose archaeological deposits within the churchyard

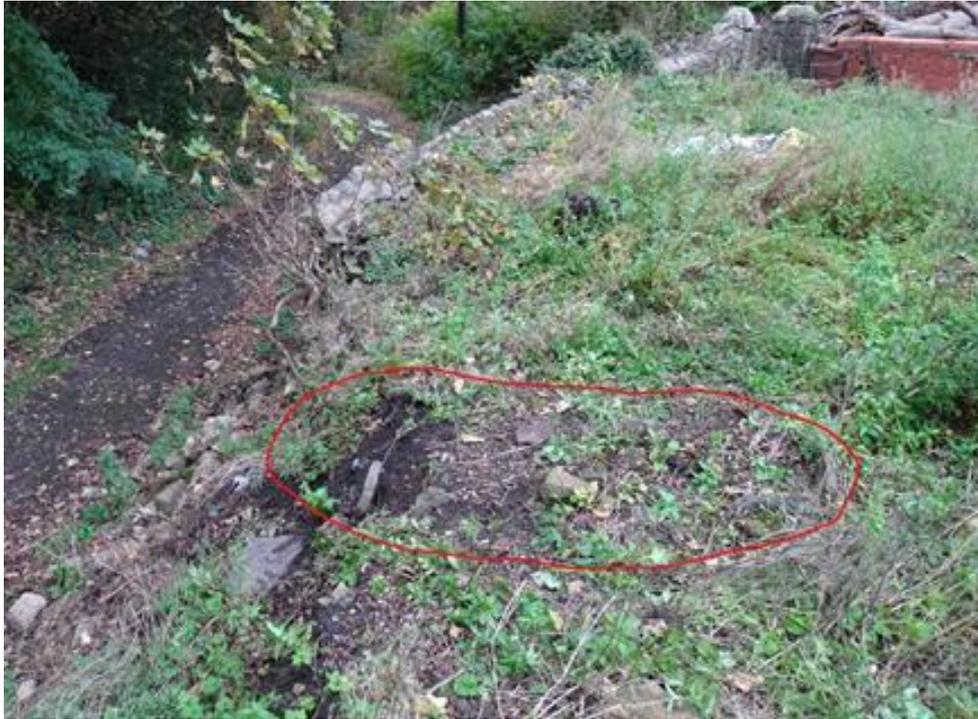
Photo 1: Grave marked by a small headstone within the area of ground reduction works.

- 4.5 One east-west grave has been identified within the area where ground reduction works are due to take place (Photo 1, Figure 3). It is probable that this burial no later than 19th century in date as the cemetery closed in 1907.
