# **St Mary's Parish Church, Rogiet, Monmouthshire.**

**Watching Brief Report  
for the Installation of a new lightning conductor,  
installed 25/11/2021.**

## Watching Brief Report for Installation of a new lightning conductor, installed 25/11/2021.

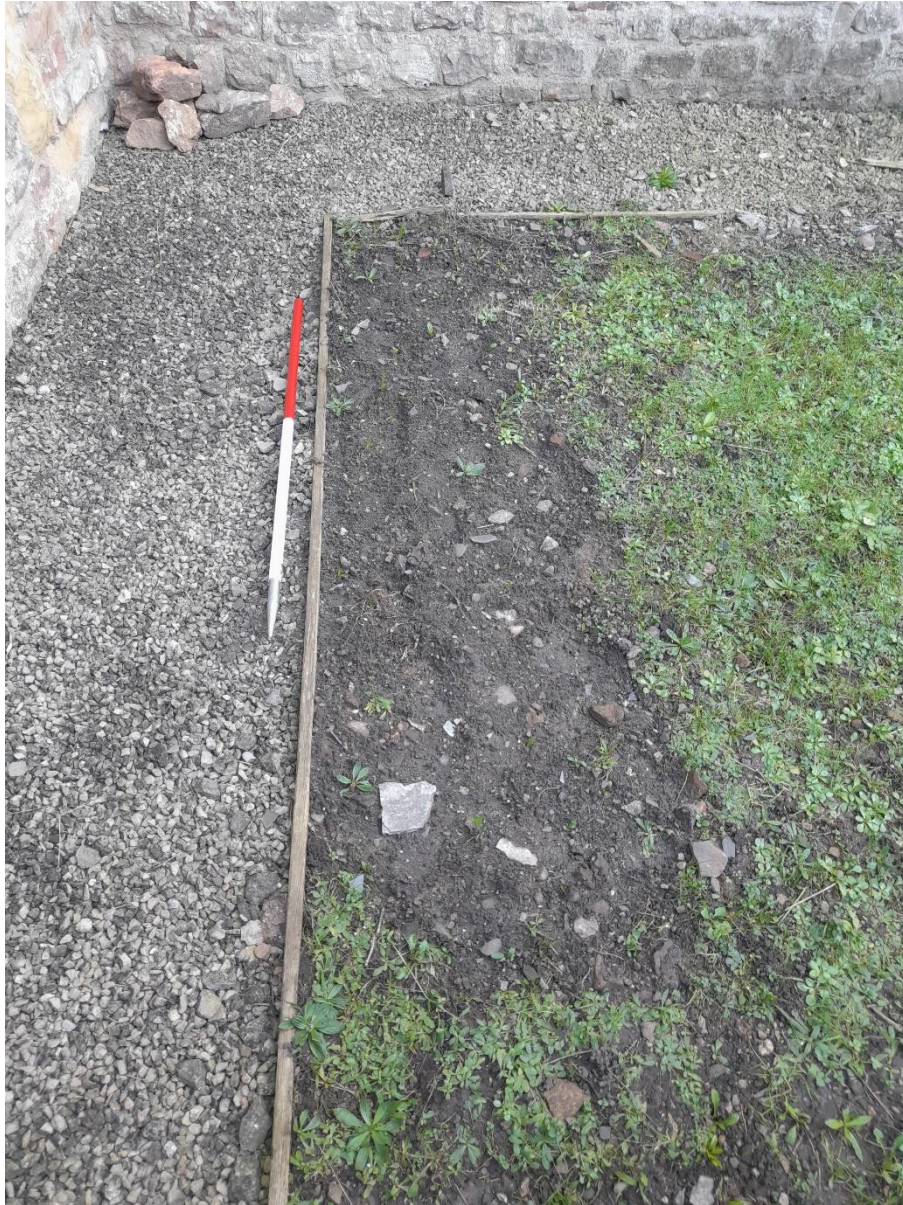
Figure 2. The backfilled lightening conductor trench looking southwards towards the north wall of the church tower. The connecting-wire trench may be seen extending from the south end of the trench to the west (right in this photograph). The connecting wire trench was excavated to a depth of c. 200mm, within the dark/brown-black humic topsoil. 1-metre surveying pole, in 0.5m divisions, pointing grid NNE.

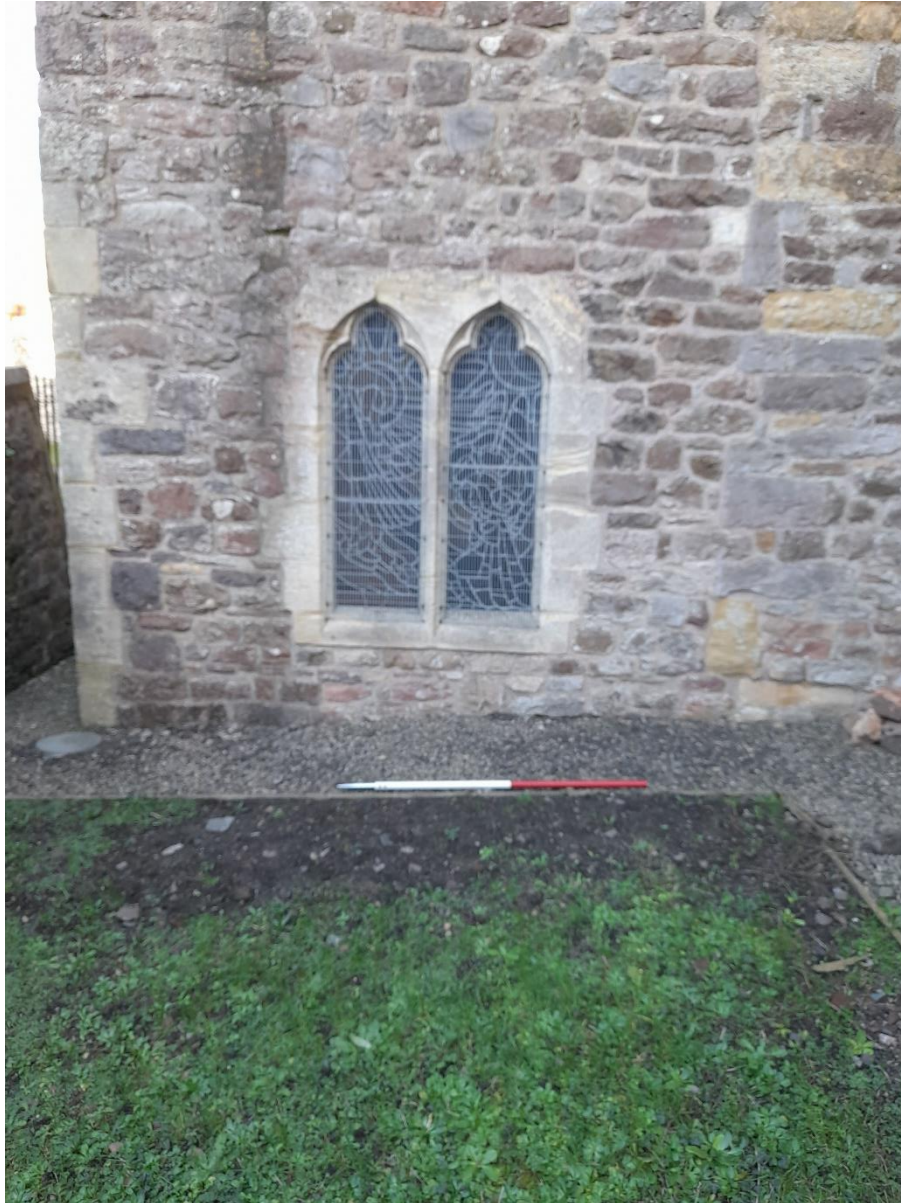
Figure 3. The backfilled lightning conductor trench looking eastwards towards the west wall of the north aisle. The connecting wire trench may be seen extending from the south end of the trench to the west (bottom-right in this photograph). The connecting wire trench was excavated to a depth of c. 200mm, within the dark/brown-black, humic, topsoil (001). The ground surface slopes gently downwards from south to north, from 12.48m OD to 12.35m OD (as surveyed by dumpy level from the Benchmark located on the western face of the church tower, recorded on the OS sheets as at 41.69 feet ODN or 12.71m ODN).

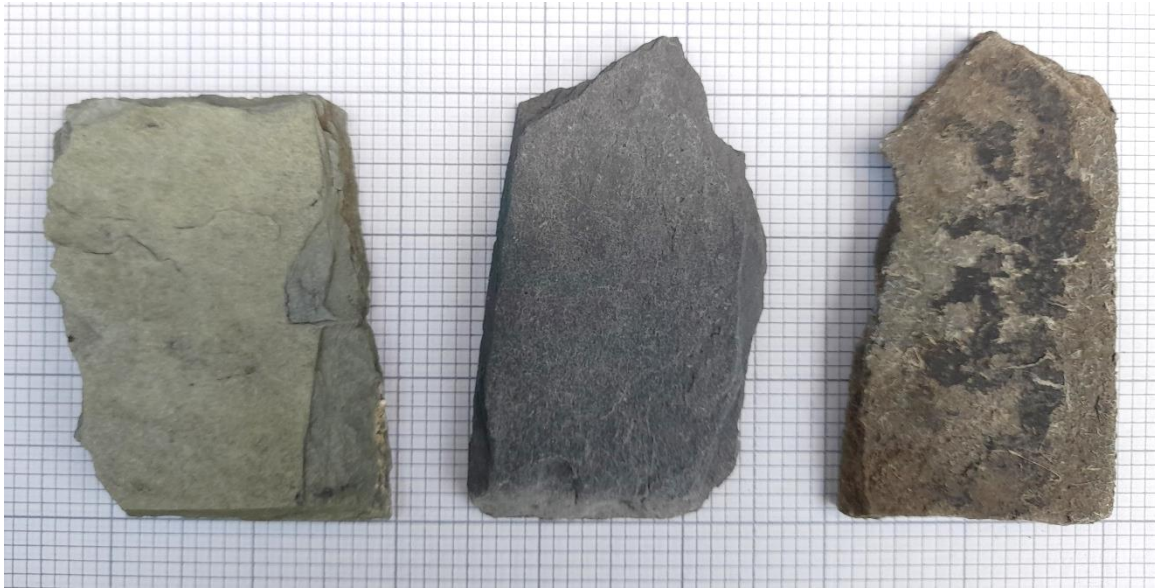
Figure 4. Post-medieval roof slate fragments from the excavated trench. The examples (left and, possibly, middle) probably represent remnants of a Devon (or Cornish) greenish-grey slate roof that was subsequently at least partially replaced with slate probably of North Wales origin (*possibly* the middle example, if not of West Country origin) during the 1903 renovation of the church, if not earlier. These two fragments have surviving corners that indicate that the lowermost corner angles of each complete slate were acute rather than right-angled. The fragment of grey-green slate (left) retained *possible* evidence of wet laying in the form of a very small patch of adhering mortar with sandy inclusions; but dry laying was probably more likely, the patch a possible spillage or other accidental contamination. None of the fragments were complete or large enough to suggest slate sizes or systems in their own right (e.g., derived from rivings, or from common, sized, rag, or scantle systems).

One fragment of a modern composite roof-slate (right) was recovered, but this is probably derived from the adjacent farmyard building.

Grey-green fragment of slate (left): SF 01 (002) Length: right-hand edge 59mm, width: lower edge 36mm, thickness: 5.2mm. With a grey-green colour, but with yellow-brown weathered surfaces, a Combe Martin origin is possible. In Fig. 4 (above), the lower and right-hand edges are true, trimmed, edges.

Grey fragment of slate (middle): SF 02 (002) Length: left-hand edge 58mm, width: lower edge 32mm, thickness: 4mm. In Fig. 4 (above), the left and bottom edges of the fragment are true, trimmed, edges.

Modern composite fragment (right): SF03 (002) Length: right-hand edge 62mm, width: lower edge 38mm, thickness: 5mm. Probably derived from the adjacent farmyard building.

Finds within, and throughout this layer (002), to the limit of excavation, included plate glass (fig. 5) and Cornish or Devon roofing slate (fig. 4), suggesting that the ground here has been disturbed, or dumped, probably at the time of the rebuilding of the north aisle, and re-roofing, in 1903 (see the HER description of the Seddon restoration and enlargement). The eastern elevation of the trench exposed the geotextile lining of an early 21<sup>st</sup> century stone chipping-filled French drain running around the church (figs 1 - 3) to a depth of c. 450mm. Although a large quantity of angular and roughly dressed limestone was encountered in (002), especially in the eastern and northern sides of the trench, no distribution pattern was observed, and the stone is interpreted (see above) as building rubble associated with building works at the church, most likely resulting from disturbance associated with the construction of the present north aisle, or as a dump of material, which materially raises the level of the churchyard (especially with respect to the west wall of the north aisle) in this area.

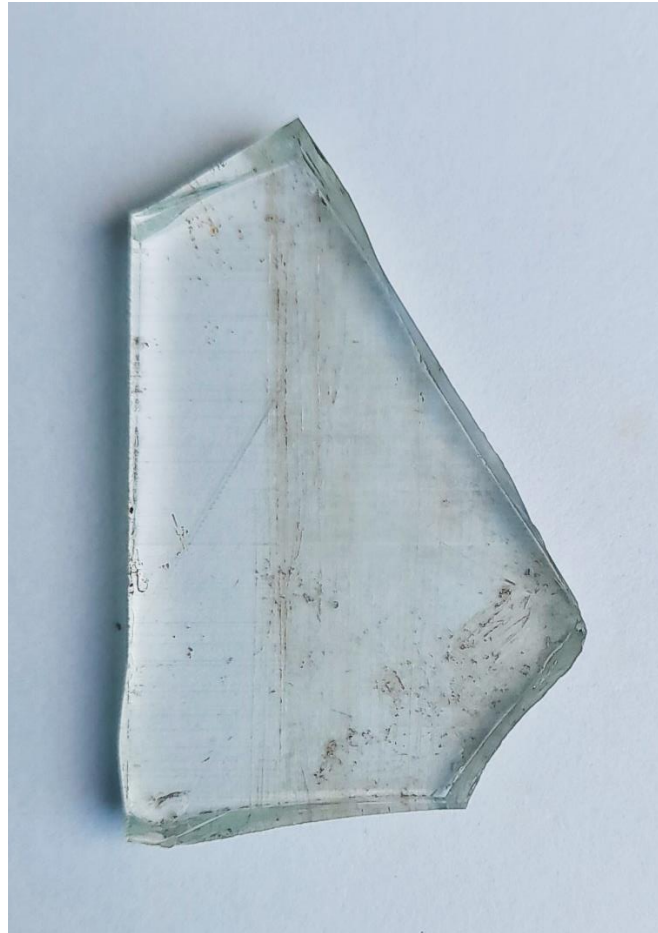
Figure 5. SF 04 (002). This fragment of decolourised (water-white) window glass shows the distinctive parallel-striated surfaces (inner and outer) characteristic of 19<sup>th</sup> - early-20<sup>th</sup> century machine-produced cylinder glass, or, *possibly*, Fourcault process glass from post AD 1900 (all pre-c.1940, when float glass became available). The striations resulting from the production process may be seen running horizontally in this image. Partial surface weathering (the darkened right-hand section in this image) suggests that this piece of glass came from a leaded light, probably derived from a former window of the church. This window was probably damaged either during the 1903 restoration or was replaced by one of the modern stained-glass windows of the north aisle; most likely the nearest, located in the west wall of the aisle. The fragment is noteworthy for the severe extent of weathering and linear abrasion on one of its two surfaces whilst it was contained by the lead came of 6mm heart depth (i.e., lead covering 6mm of the edge of the quarry, which is the undarkened, left-hand, section in this image).

SF 04 (002) Length: left-hand edge 29mm, width: 21mm, thickness: 3mm.

Unweathered edge c. 6mm.

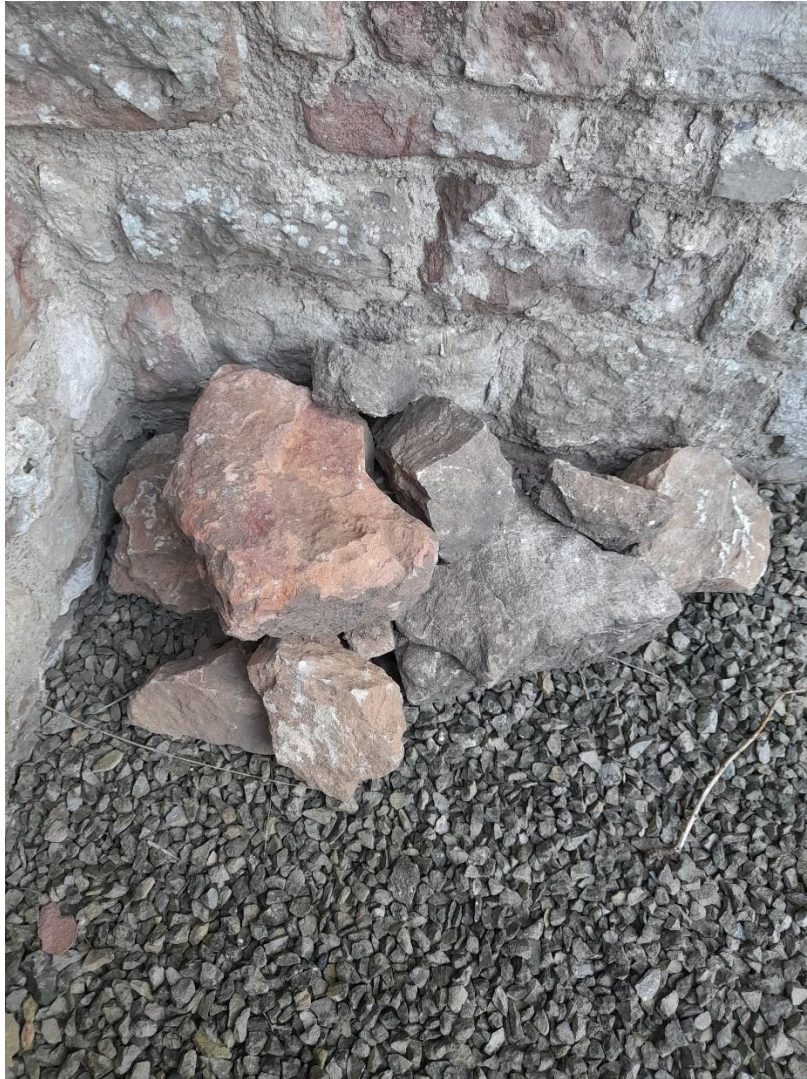
Figure 6. Some of the excess limestone rubble left after back-filling. These stones are representative of the loose rubble encountered within the trench, and subsequently mostly backfilled. The image shows their coarseness and overall lack of any (or any surviving) mortar.

Topsoil comprised a dark-brown/black humic turf layer (001). A single context of orange-brown, sandy, soil with extensive limestone rubble of varied sizes and occasional decayed sandstone fragments (fig. 6) lay beneath down to the limit of excavation (002).
